Research Report on Impacts of Hokkaido Eastern
Iburi Earthquake on CO₂ Reservoir

November 2018

Japan CCS Co., Ltd.

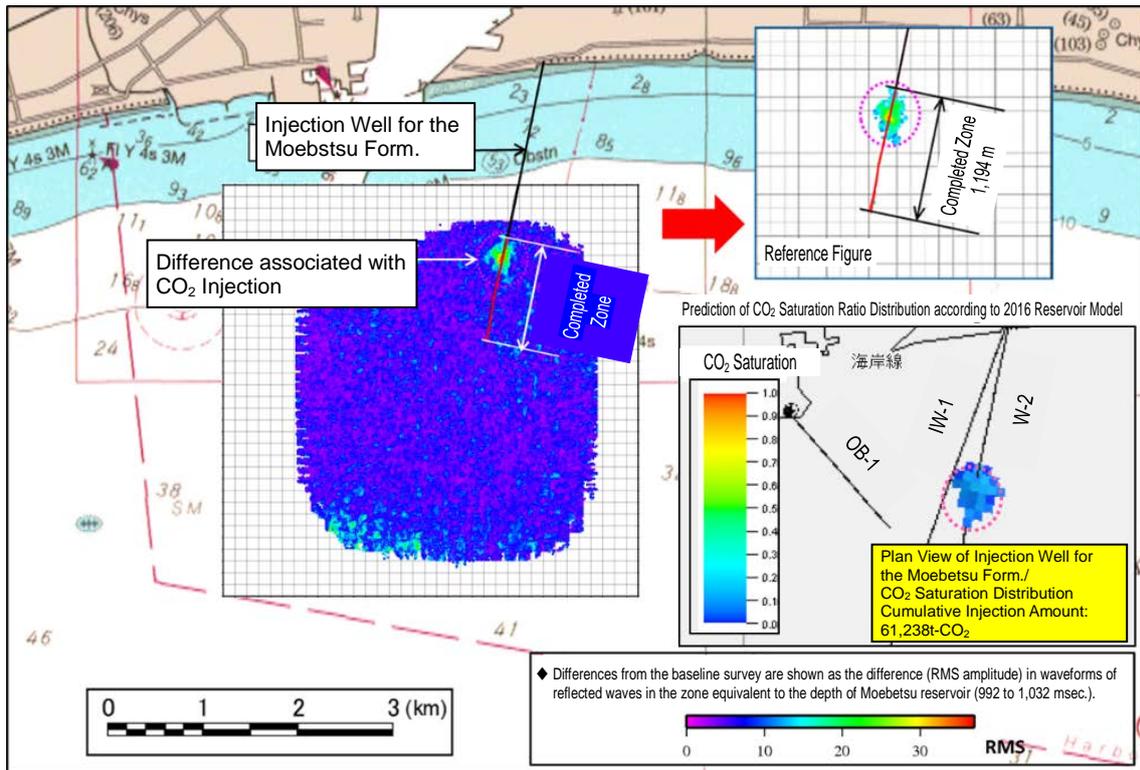
Figure 3: Results of Monitor 3D Seismic Survey

As for the behavior of stored CO₂, a 3D seismic survey was implemented in 2017 at cumulative CO₂ injection of 65,000 tonnes into the Moebetsu Formation, and a comparison with the reflected waves of a baseline 3D survey conducted before the start of CO₂ injection detected a difference in the seismic waves (Figure 3). This difference is believed to indicate the distribution of the stored CO₂, which shows a distribution similar to the prediction results of CO₂ behavior simulation at cumulative injection of 61,238 tonnes implemented in advance. Calibration of the reservoir model by a comparison of the prediction and the actual measurement is expected to improve the accuracy of the model and contribute to the prediction of the future CO₂ distribution.

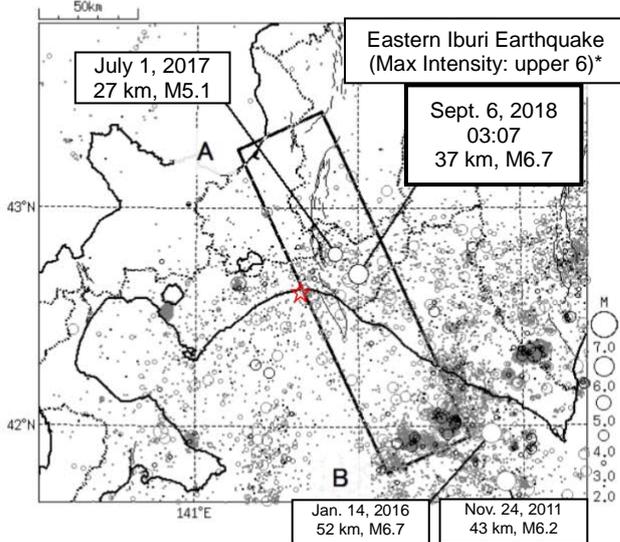
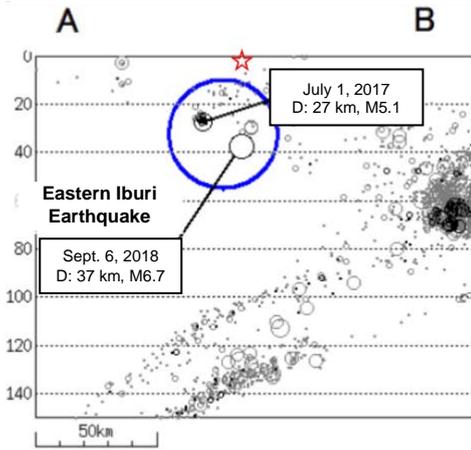
Figure 4: Hypocenter of Hokkaido Eastern Iburi Earthquake

Epicenter Distribution Map
(Earthquakes from Oct. 1, 1997 to 03:30 Sept. 6, 2018; Depth: 0 to 150 km; M2.0 or over)
Earthquakes from January 1, 2018 onwards shown in darker color.

**Cross-section along A-B
within square zone of left figure**

Vertical axis denotes depth; size of circles denote magnitudes.

On September 6, 2018, at 03:07, an M6.7 earthquake occurred at a depth of 37 km in the central eastern Iburi region (announcement by Japan Meteorological Agency), and a seismic intensity of 7 was recorded at Atsuma Town, Hokkaido, while the intensity was lower 5 (158 gal) at the Demonstration Project Center. According to material released by the Japan Meteorological Agency, if we take a look at seismic activity since October 1997, earthquakes of around M4.0 and greater have occurred from time to time around the hypocenter of the Earthquake, and on July 1, 2017, an M5.1 earthquake occurred at a depth of 27 km (Figure 4). According to public material, the regional subsurface structural framework is believed to be that the Pacific plate is moving obliquely into the Kuril Trench, dragging the earth's crust of the Kuril Islands (Kuril Arc) from the east, which pushes and collides with the NE Japan Arc (Figure 5). It is believed that when this happens, the upper crustal part of the Kuril Arc is thrust upwards and forms the Hidaka Mountain Range, and the lower part splits and slides downwards beneath the NE Japan Arc, which is also dragged downwards. As a result, the earth's crust is thicker around the Hidaka Mountain Range and to the west (Figure 5).

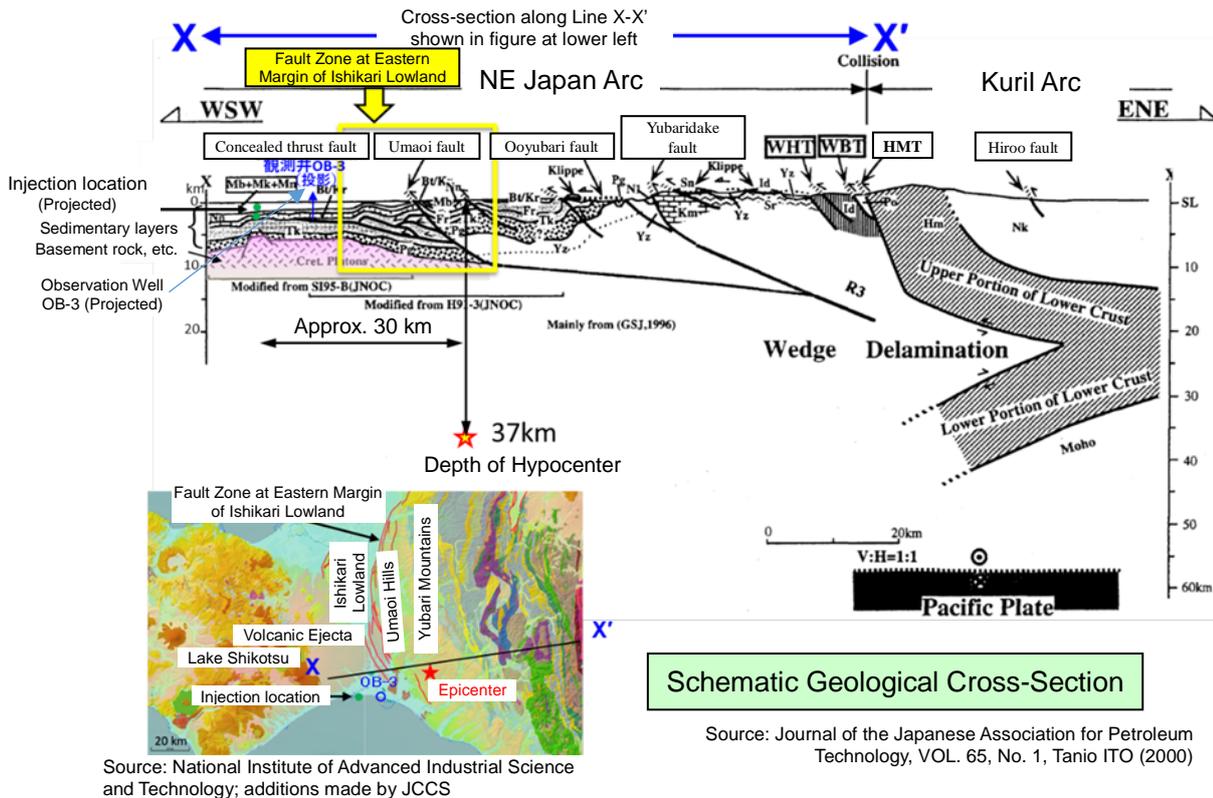
Figure 6: Hypocenter of Hokkaido Eastern Iburi Earthquake and schematic geological cross-section

In addition, the hypocenter of the Earthquake officially announced by the Japan Meteorological Agency is located at a depth of 37 km in basement rock, which has no continuity with the sedimentary layers into which CO₂ is being injected (Figure 6).

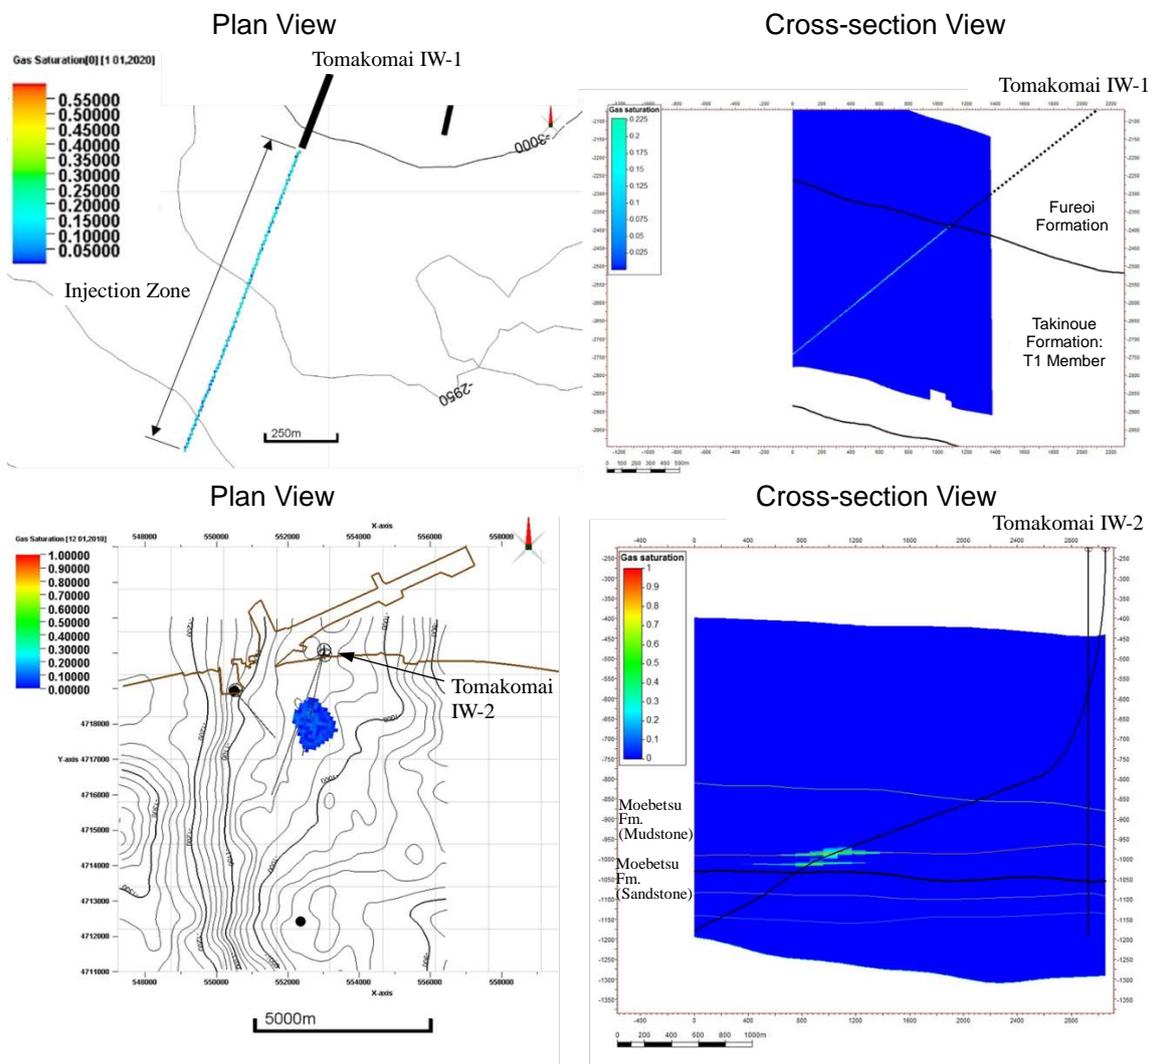
Figure 9: Prediction of behavior of stored CO₂: Degree of CO₂ saturation (at the end of injection); Takinoue Formation (Top), Moebetsu Formation (Bottom)

In order to examine the impact of the CO₂ injection on the earthquake source fault, we conducted simulations of CO₂ behavior at the end of the CO₂ injection with the assumed cumulative injection amounts (300,000 tonnes into the Moebetsu Formation, and 750 tonnes into the Takinoue Formation) using reservoir models updated by the actual injection record (as of July 2018), and we estimated anew the CO₂ distributions (Figure 9) and pressure rise (Figure 10) in the reservoirs. Regarding the Takinoue Formation, in which the rise in reservoir pressure would be largest, it was found that even when the pressure in the injection well was increased by about 5 MPa (considering the upper limit of the injection pressure), the pressure rise in the 50m area surrounding the injection interval reaches 2 MPa, reducing to approx. 0.25 MPa or less 1 km away. As for the Moebetsu Formation, the upper limit of the injection pressure of the injection well results in an increase by about 0.7 MPa, based on past injection records.

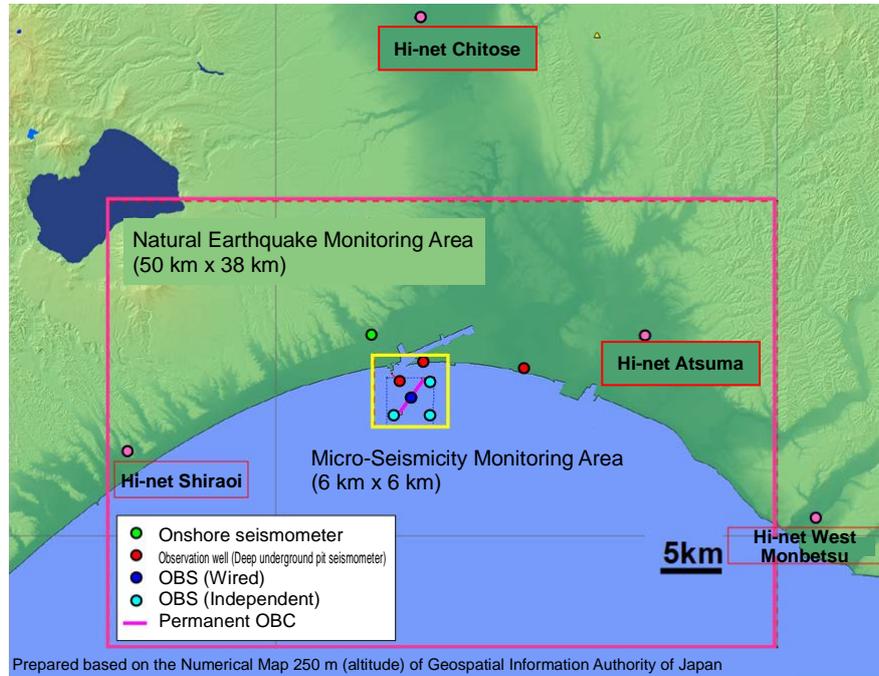
Figure 11: Allocation of Earthquake Observation Points and Monitoring Area

The above data is combined with four Hi-net government observation station data to monitor natural earthquakes covering a 50 km east-west, 38 km north-south and 50 km deep area-shown in Figure 11.

In addition, within this area, a 6 km east-west, 6 km north-south and about 15 km deep area surrounding the injection point is defined as the Micro-Seismicity Monitoring Area (“monitoring area”), and focuses on the observation of micro-seismicity that could occur in association with the injection. In this observation system, seismic events^{*3} having a magnitude of -0.5 or greater can be detected. ^{*3}Vibrations are to be called as events in the stage where the features of detected vibrations are not identified.

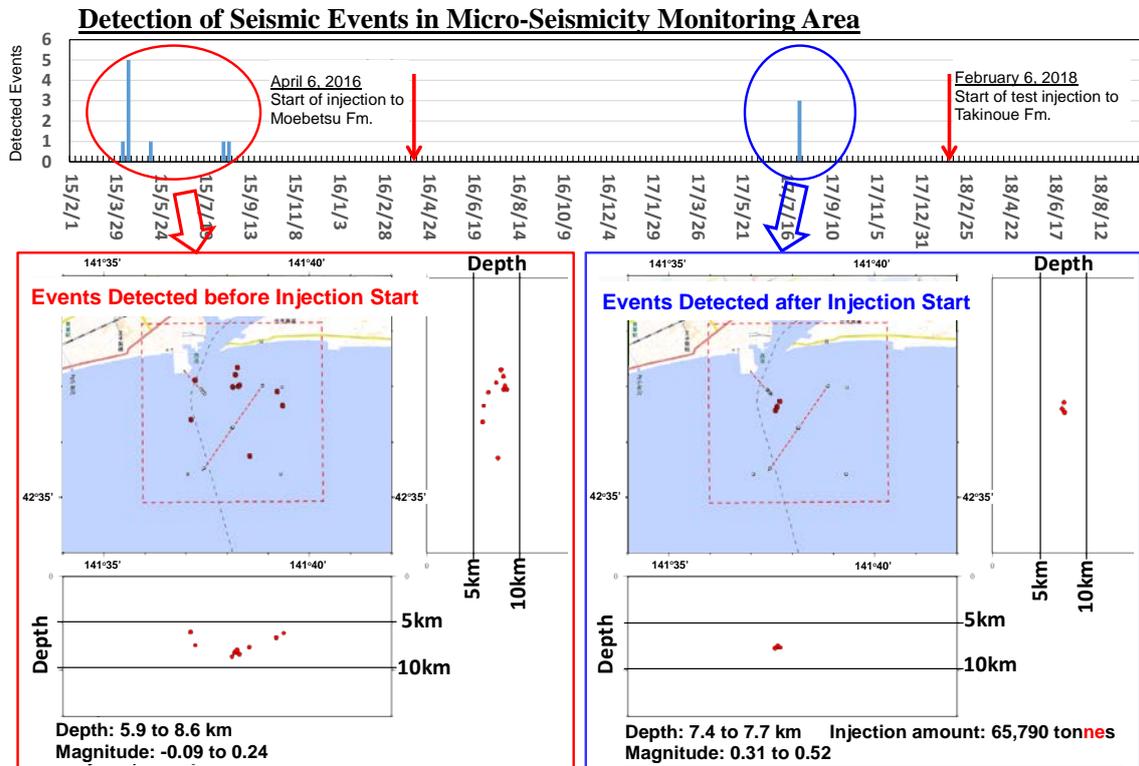
Figure 12: Event Detection Status in Micro-Seismicity Monitoring Area

Figure 12 shows the number of micro-seismic events and estimated epicenter locations detected in the monitoring area during the period from February 2015 to the end of September 2018. Prior to startup of injection, nine micro-seismic events between April to August 2015 were detected in the monitoring area, and three events in August 2017 after the implementation of injection. These micro-seismic vents all occurred at a depth of about 6 km or greater, which meant that vibrations associated with the minimal scale natural earthquakes that could normally occur in the area were captured. After the three micro-seismic events in August 2017, no such events have been detected in the monitoring area, including the period before and after the 2018 Hokkaido Eastern Ibari Earthquake.

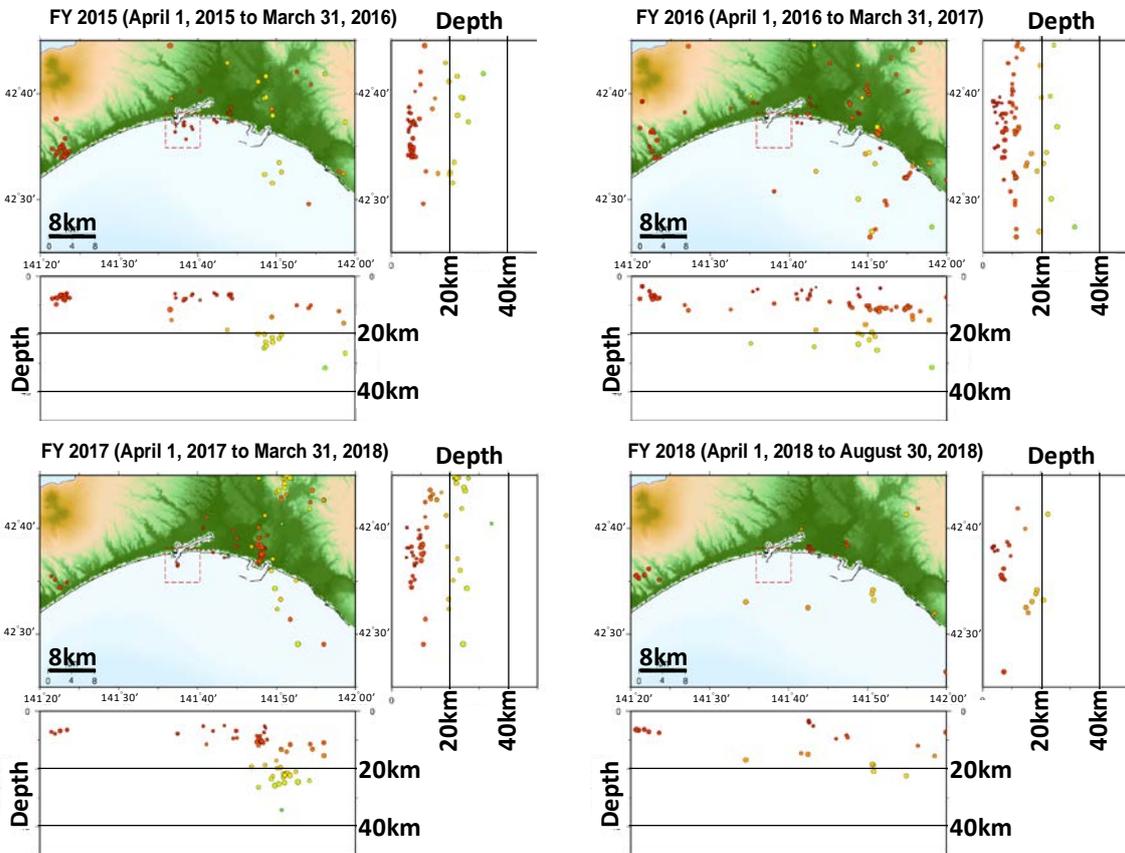
Figure 13: Observation Results of Natural Earthquakes in 2015 to 2018 (Results til the end of August for FY 2018)

Figure 13 shows the results of natural earthquake monitoring in the Natural Earthquake Monitoring Area for each fiscal year from 2015 to 2018 (results until the end of August for FY 2018). In each year, salient seismic activities are noted around the area south of Mt. Tarumae and the peripheral area of the southern part of the Eastern Boundary Fault Zone of the Ishikari Lowland and its extension. Although the seismic activity of FY 2017 is characterized by a concentration of small and micro-seismicity in the vicinity of the eastern division of Tomakomai Port, many small and micro-seismic events were detected in each fiscal year, and no salient time-oriented fluctuation was noted before and after startup of injection. In addition, no salient change was noted immediately before the occurrence of the Earthquake either.

After the main shock, in accordance with the activation of the overall seismic activity around the hypocentral area, many small and micro-seismic events were detected near the eastern division of Tomakomai Port. As previously mentioned, because many small and micro-seismic events have been observed in this area since before the earthquake, these events are believed to be a part of the aftershock activities occurring after the main shock. In addition, though there is a salient increase in the number of occurrences, the hypocenter locations do not fall outside the hypocenter distribution prior

to the Earthquake. Furthermore, no change in the seismic activity area corresponding to the Earthquake is observed in the vicinity of the storage location (Micro-seismicity Monitoring Area).

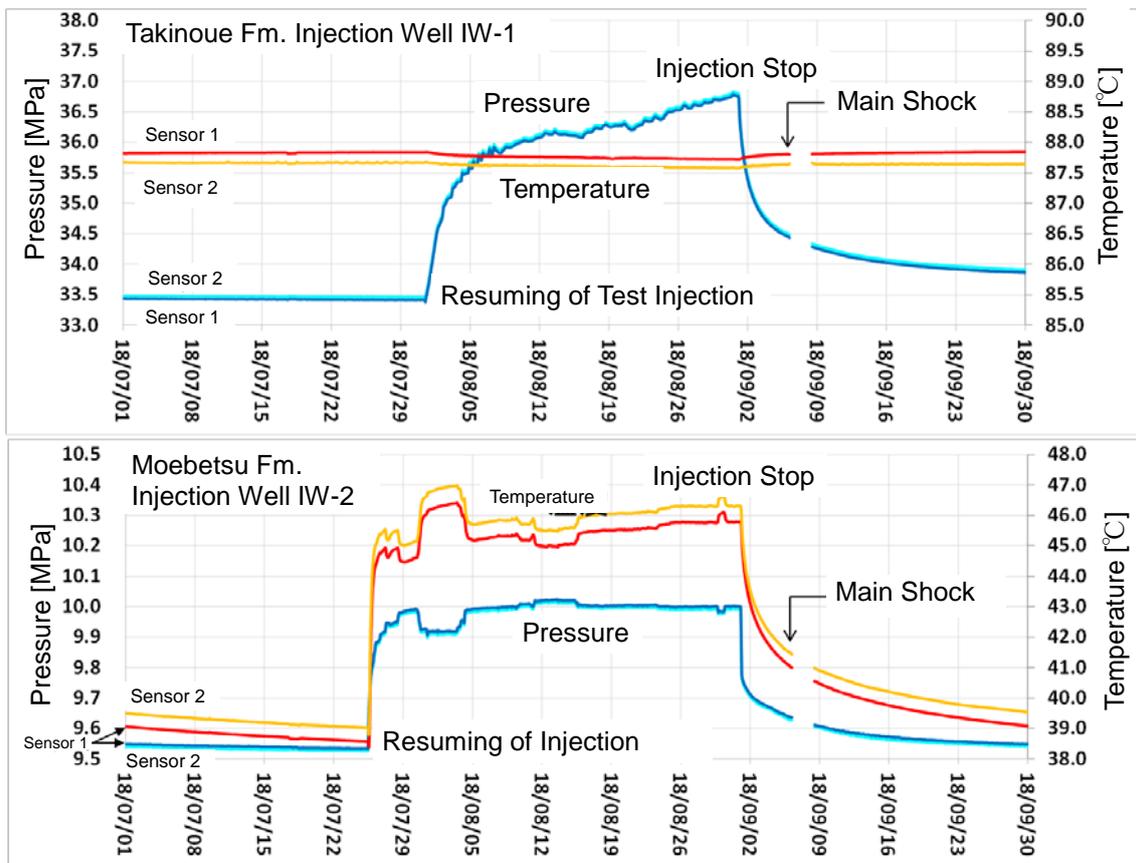
Figure 14: Observation Results of Temperature/Pressure in Injection Wells before and after Hokkaido Eastern Iburi Earthquake of 2018

In this project, temperature/pressure observation is being implemented in the injection wells with high-precision sensors using silicon oscillation devices. Figure 14 shows the observation results of temperature/pressure in the injection wells for the three months from July 1 to September 30, 2018. In the Takinoue Injection Well (IW-1), test injection was resumed on July 30, 2018, and in the Moebetsu Formation Injection Well (IW-2), full-fledged injection was resumed on July 25, 2018. However, the injection had been stopped due to the stoppage of CO₂-containing gas supply from the source on September 1, 2018, prior to the occurrence of the Earthquake, and the pressures in both injection wells were on a downtrend as a result of the injection stoppage. The downhole temperature when the earthquake occurred was on an upward trend in IW-1 because the injection CO₂ temperature was lower than the formation temperature. On the other hand, in IW-2, the downhole temperature was on a downward trend because the injection CO₂ temperature was higher than the formation temperature. As shown in Figure 14, although there is a gap in the data due to an island wide blackout, there is no change in the trends before and after the earthquake.

It should be noted that, the pressure rise during injection in IW-1 reflects an injection test to investigate the relationship between the injection amount and pressure, wherein the pressure had been increased to 37 MPa, which was lower than the upper pressure limit (38 MPa).

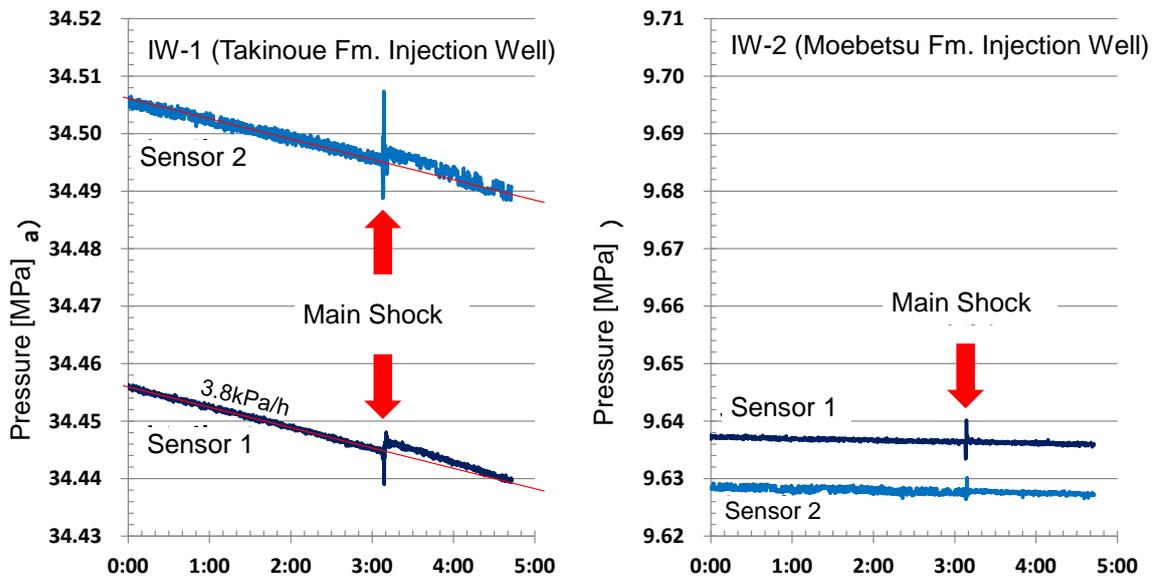
Figure 15: Micro Variations in downhole Pressure right after Hokkaido Eastern Iburi Earthquake of 2018 (Vertical scale is unified to 0.01 MPa.)

From a broad perspective, though no change in temperature and pressure behavior attributable to the earthquakes was found, a very slight rise in the downhole pressure in IW-1 was noted just after the main shock, as shown in Figure 15. The downhole pressure rose abruptly by about 1.8 kPa^{*4} just after recording the main shock, decreasing as time elapsed and approaching asymptotically the trend of pressure drop before the main shock. The rate of pressure drop during the three hours before the earthquake was about 3.8 kPa/h. Although the complete situation is unknown because data recording stopped 95 minutes after the occurrence of the earthquake due to a power outage, it can be inferred from the asymptotic trend that the downhole pressure returned to the original downward trend within several hours. ^{*4} The pressure right before the main shock is about 34.49 MPa, and 1.8 kPa is about 1/20,000th thereof.

It is possible that the pressure rise observed here can be deemed a certain type of co-seismic variation^{*5}, and the causes of co-seismic pressure variations include variations in bulk strain caused by static crustal deformation associated with fault displacement at the epicenter of the Earthquake.

The calculation result using the model matches the observation result (rise by about 1.8 kPa), and it is possible to explain the observed pressure rise as a static crustal deformation associated with fault displacement at the epicenter.

Therefore, as the model calculation result can explain the observed result in a rational way, and because the variation of 1.8 kPa is extremely small, the pressure variation observed does not indicate any abnormality in the reservoir (rupture of the geological formation resulting in leakage of CO₂, etc.).

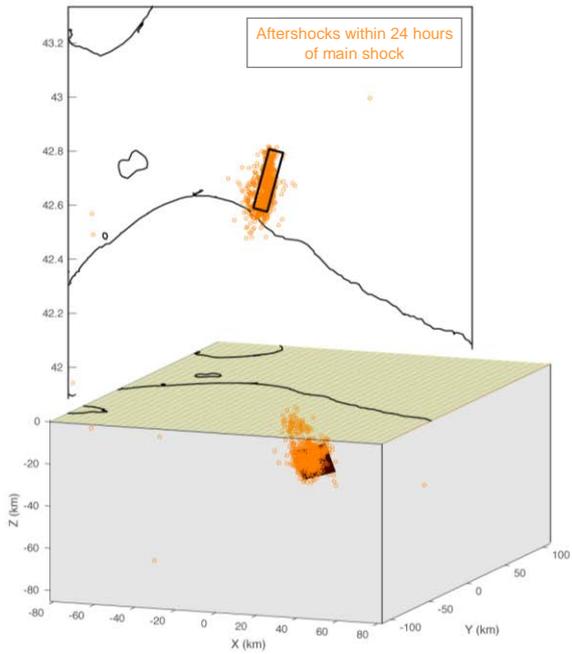
Figure 16: Model of Earthquake Source Fault

Fault Model	Longitude [°]	Latitude [°]	Depth of Upper Margin [km]	Length [km]	Width [km]	Strike [°]	Dip [°]	Rake [°]	Slip Amount [m]	M _w
Aftershocks Distribution Model	141.920	42.591	30.0	25.0	13.9	15	65	90	0.9	6.6

The homogeneous, isotropic and semi-infinite elastic body of Okada (BSSA, 1992) was used. The assumed Young's modulus is 80 GPa*; Poisson's ratio is 0.25.

Model where the initial aftershock distribution is taken into consideration (Earthquake Source Fault Model)
